National Transportation Safety Board

Maintenance Issues

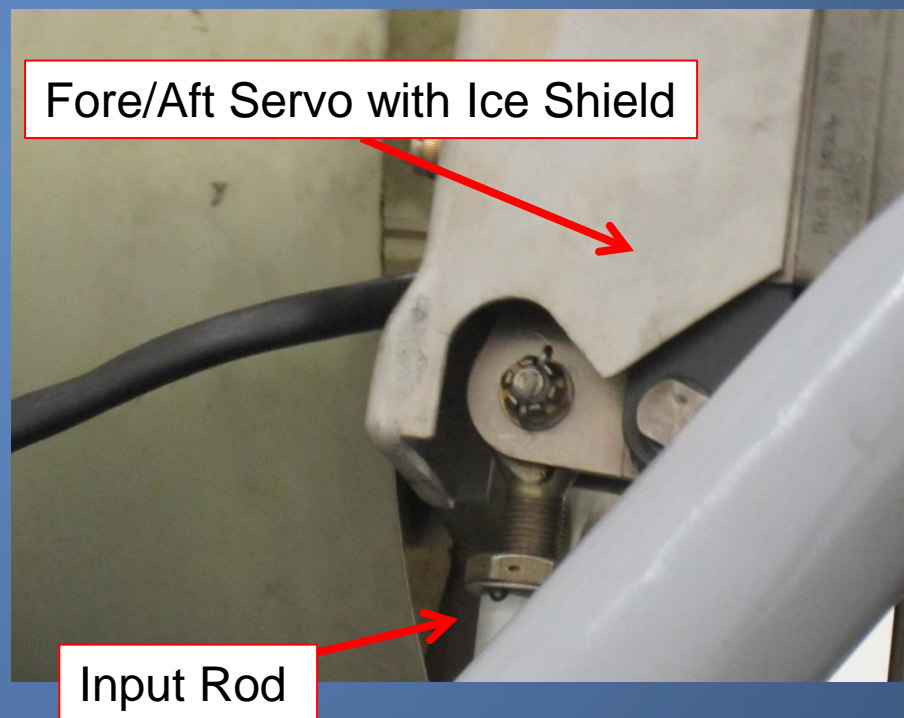
Hardware installed

- Two locking devices
 - Self-locking nut
 - Split pin
- Self-locking nut most likely became separated from bolt

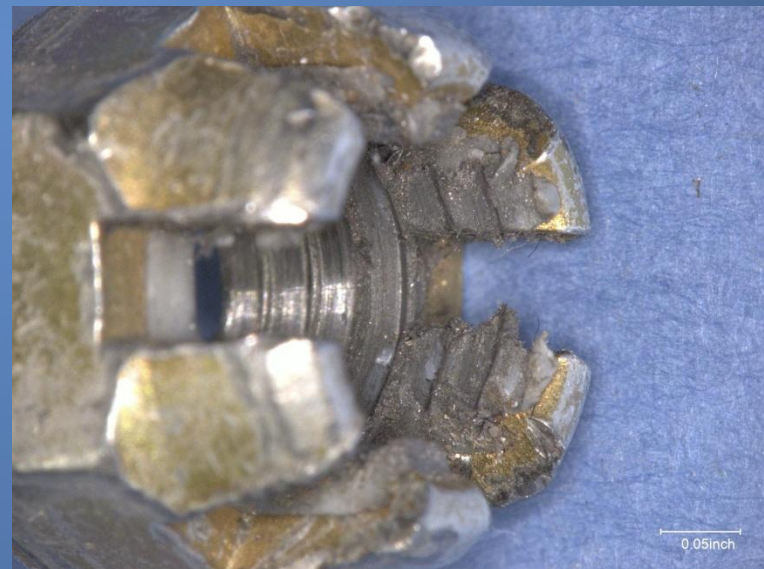
Degraded Nut

- Fleet inspection of 13 helicopters, half of nuts did not meet requirements
- Manufacturer's guidance: "If a nut can be easily tightened, it is to be discarded"
- FAA guidance: "DO NOT reuse a fiber or nylon lock nut if the nut cannot meet the minimum prevailing torque values"
